Expanded Site Inspection  
Final Report

Cottage Grove Landfill  
Chicago, Illinois  
ILD 980 497 747

December 29, 1994

Prepared for:  
U.S. Environmental Protection Agency  
under Alternative Remedial Contracting Strategy  
Contract 68-W8-0064, Work Assignment 33-5JZZ  
ARCS Contractor Project 71280.104

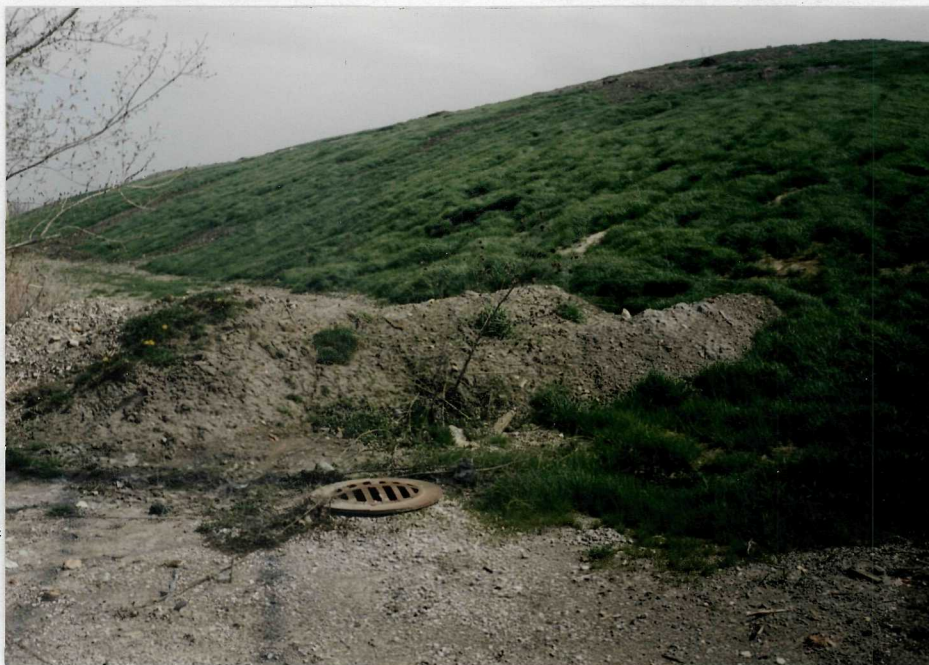
**Description:** Land & Lakes #2 stormwater inlet, located at the midsection of the Cottage Grove eastern border.

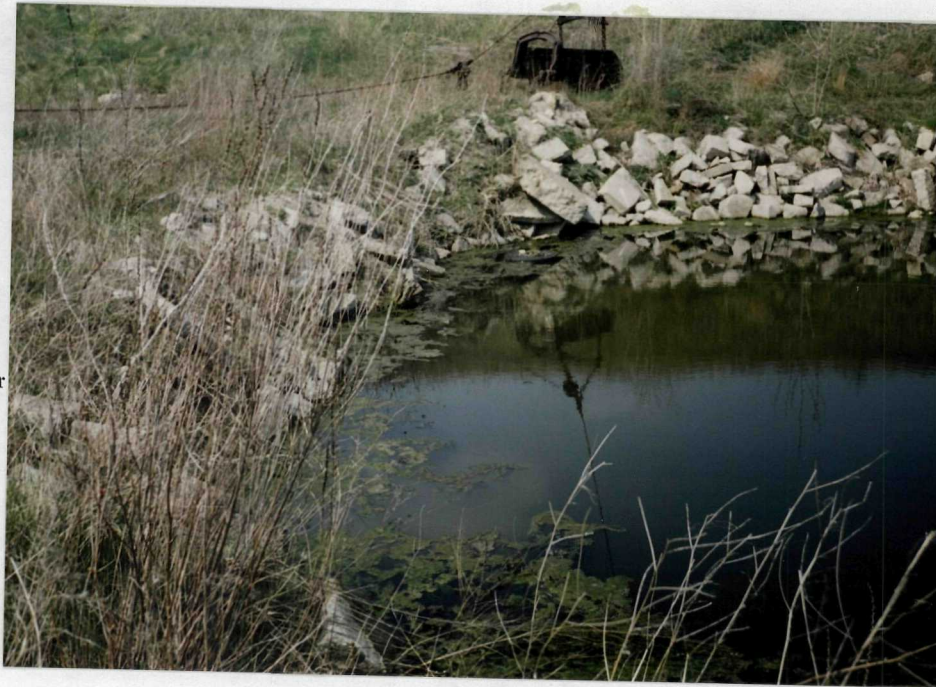
**Description:** Elevation of the landfill from the  
east side of the pond.

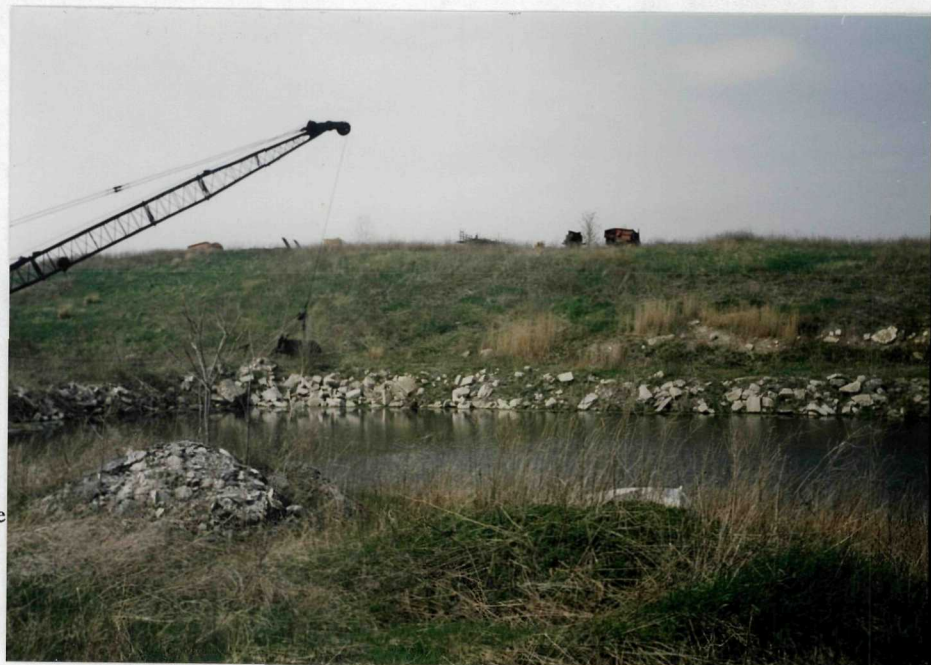
**Description:** Monitoring well #2 near the  
northwestern corner of the onsite pond.

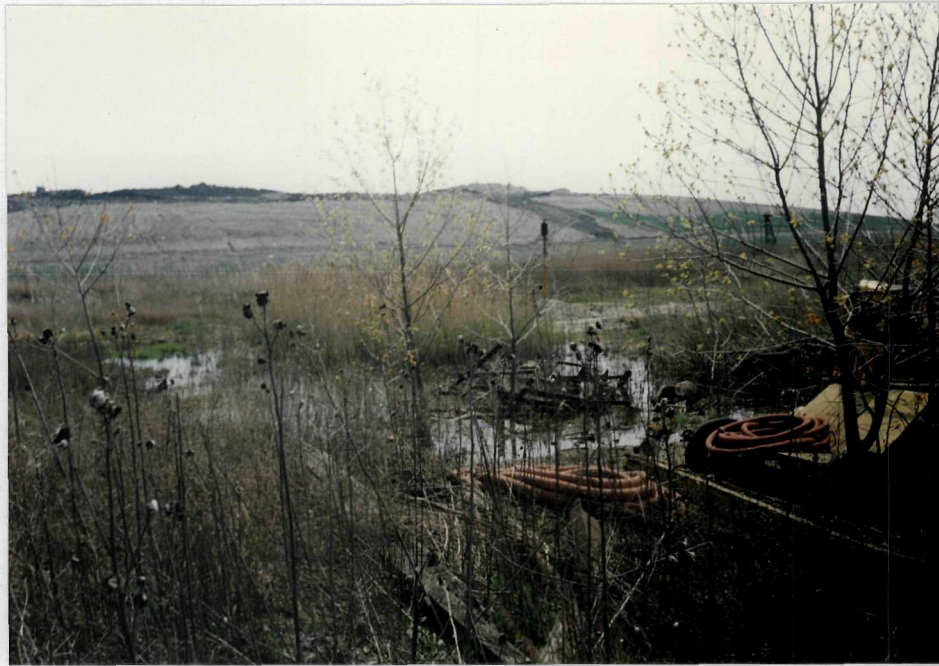
**Description:** Top of the landfill. Note the gas vents and abandoned heavy equipment.

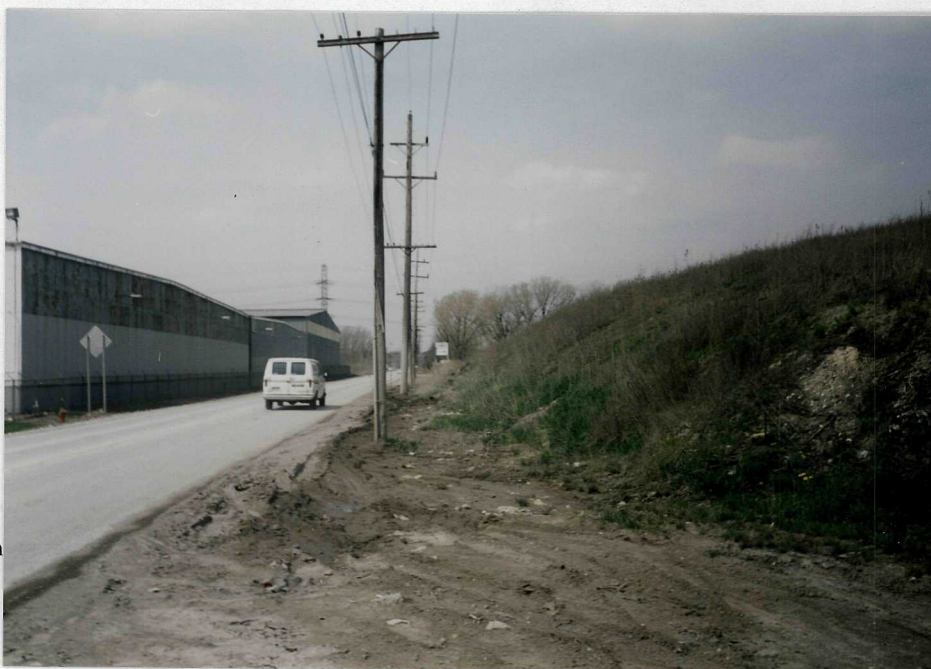
**Description:** Ditch along 138th Street running east away from front entrance to landfill. The Land and Lakes No. 2 landfill is in the background.

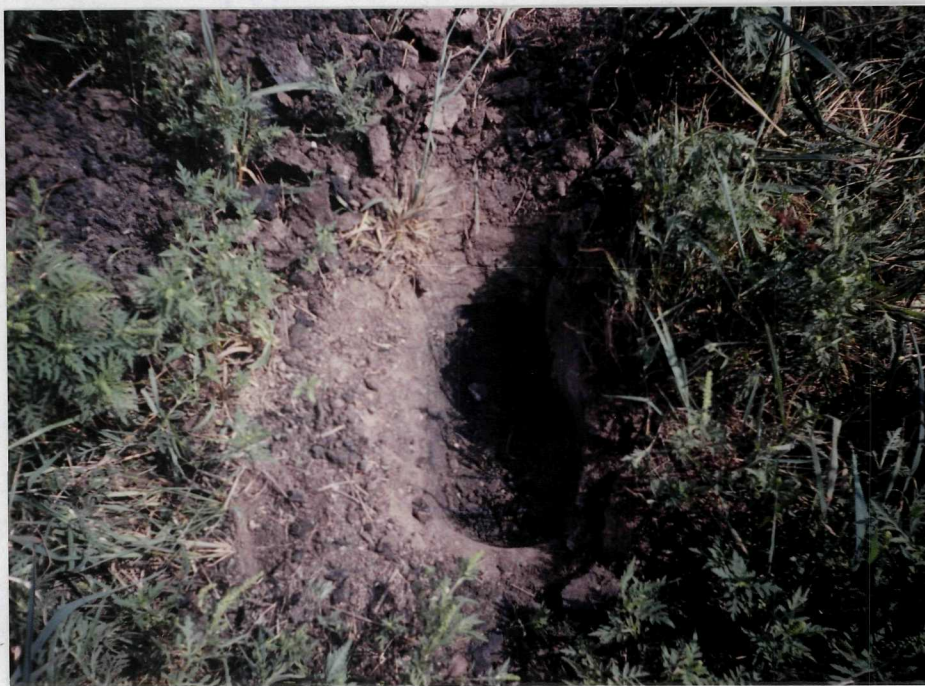
**Description:** General location of soil sample SS01 with shovel and cooler just behind sample spot and monitoring well MW03 and recreational harbor in background.

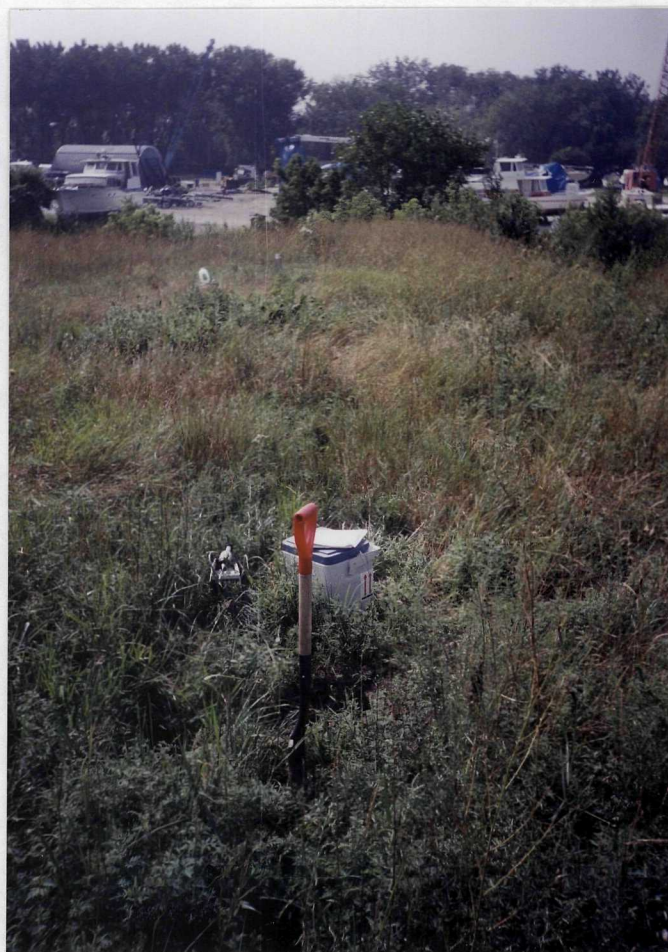
**Description:** Soil Sample SS02 collected approximately 180 feet west of the second methane gas vent from the north end of landfill. Sample jars and HNu PID equipment to the right of sample location.

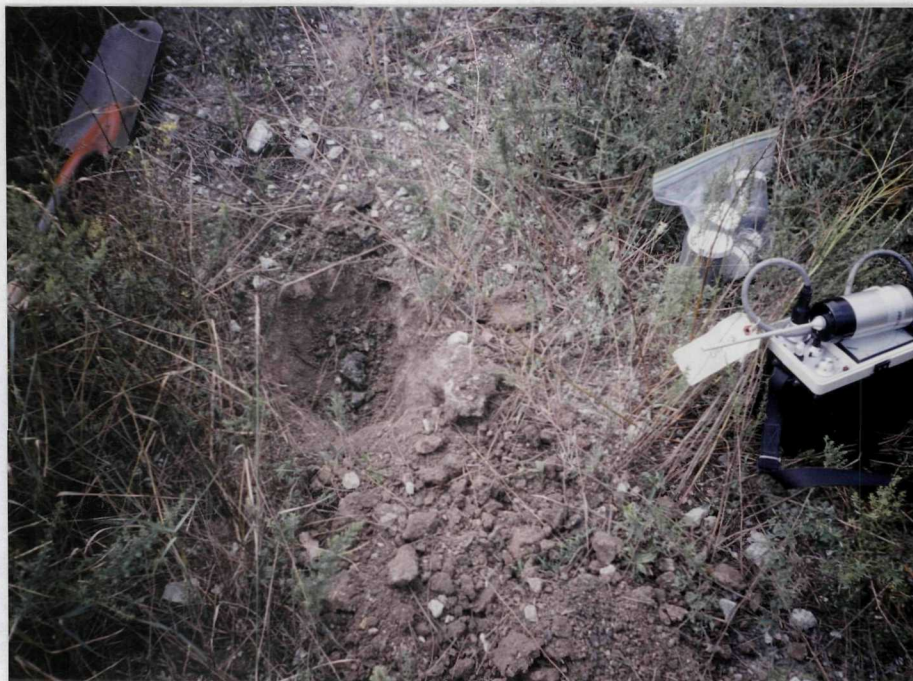
**Description:** Soil sample SS03 collected approximately 50 feet west of the south most methane gas vent with shovel right of the sample spot and gas vent in background.

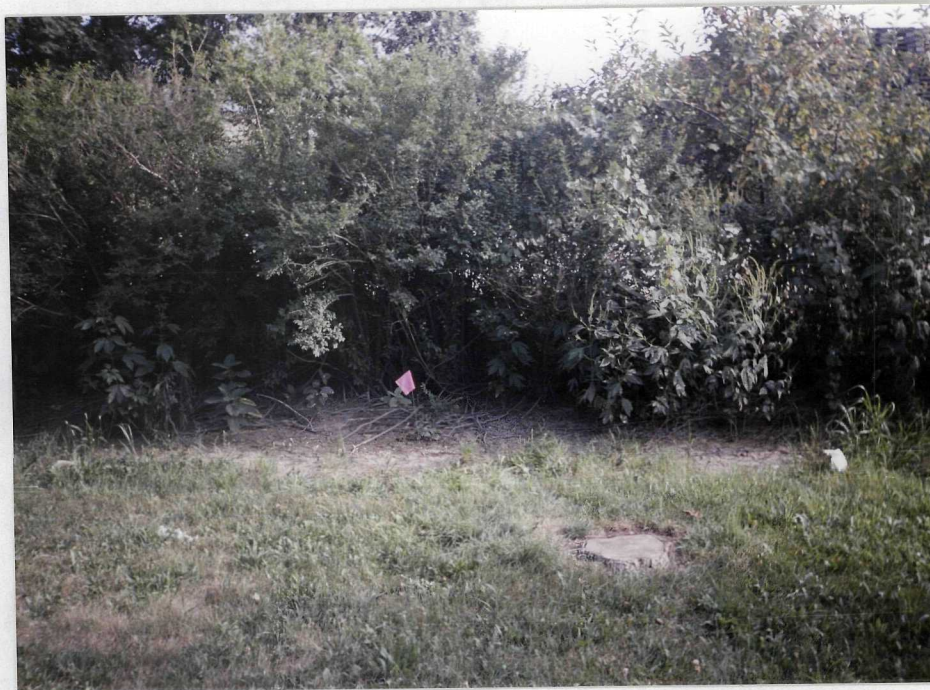
**Description:** Soil sample SS05 collected in backyard of onsite residence, approximately 30 feet north of the NW corner of the house.

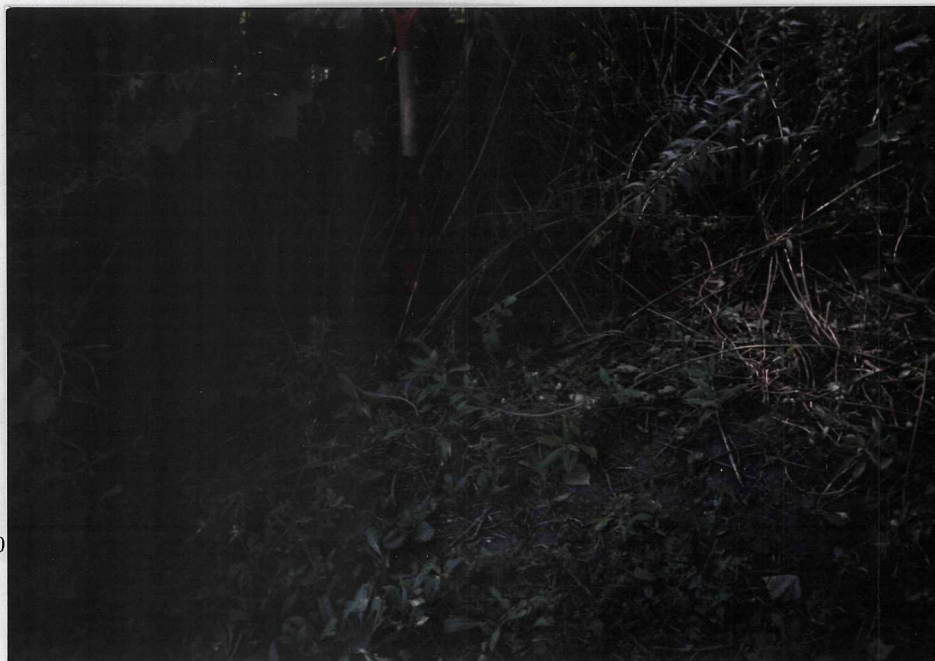
**Description:** Monitoring well MW02 with honeybee apiary and an abandoned trailer in the background.

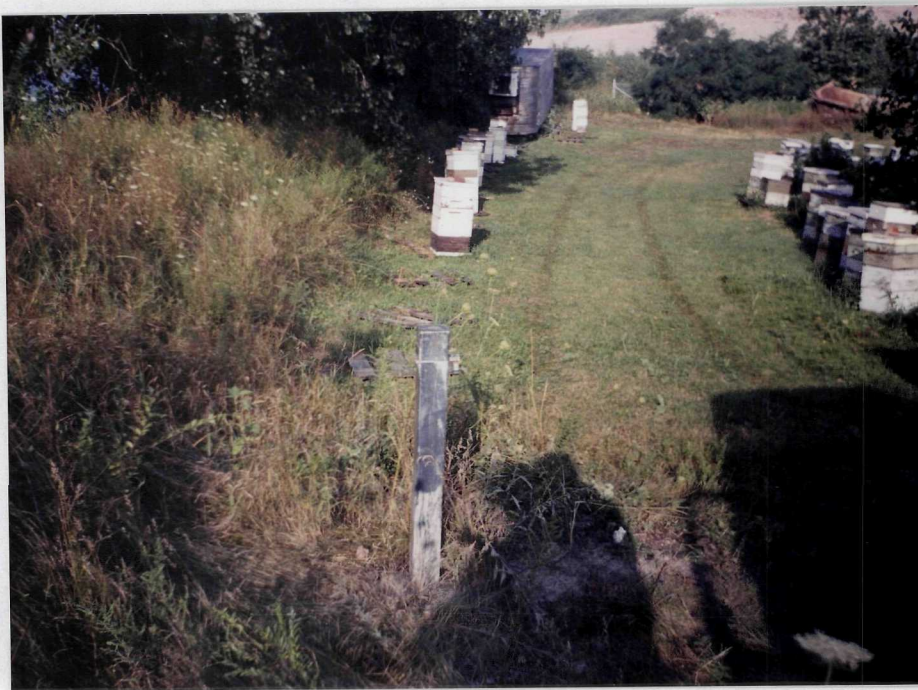
Soil sample (SS04) contained three inorganic analytes that meet observed release criteria: beryllium (0.69 mg/kg), nickel (22.0 mg/kg), and potassium (3,310 mg/kg).

**Description:** Soil sample SS04 collected near the northwestern corner of the site pond. A red flag on a two-foot wire post marks the sampling spot (approximately 50 feet south of monitoring well MW02).

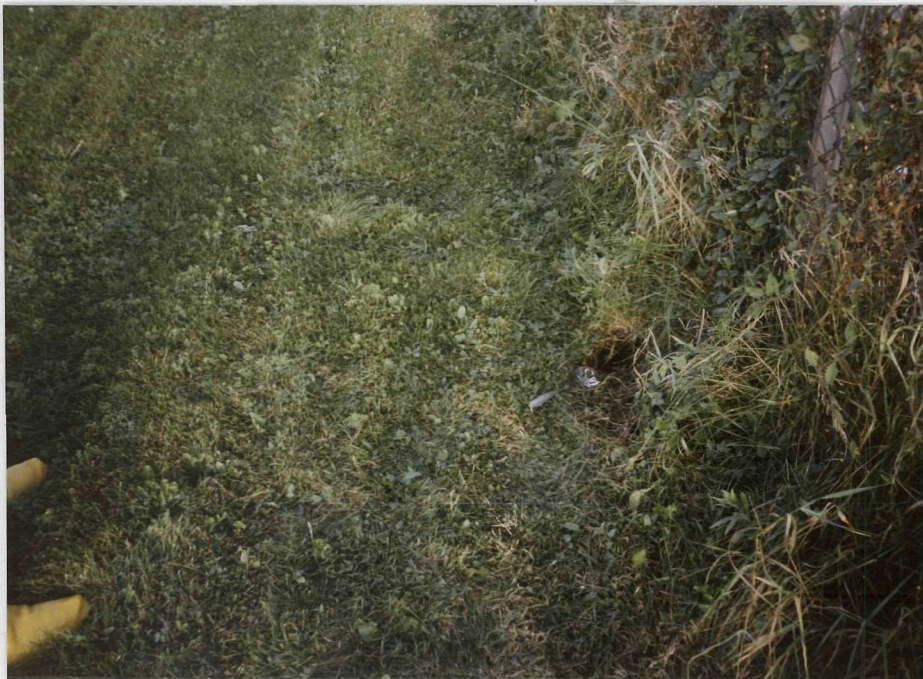
**Description:** Location of background soil sample SS08. The sample was collected at the corner of Cottage Grove Avenue and Shepard Drive about 1 mile south of Cottage Grove Landfill. A spoon marks the sample spot and the bottom of a tree trunk is in the background.

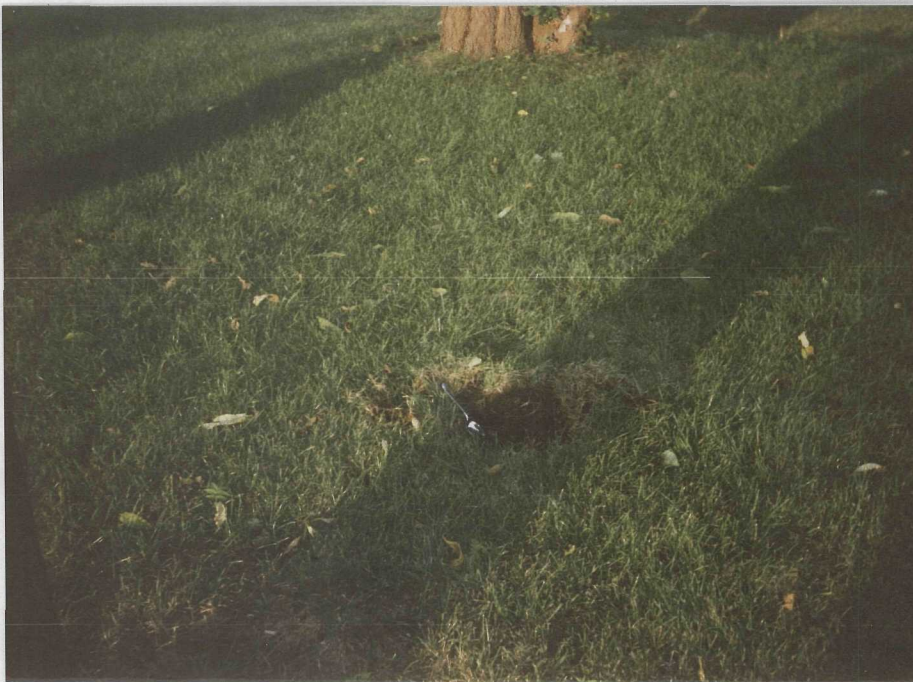
**Description:** Location of ST02 and SW05 which were collected on the eastern bank of the onsite pond (approximately 220 feet north of the southern end of the pond).

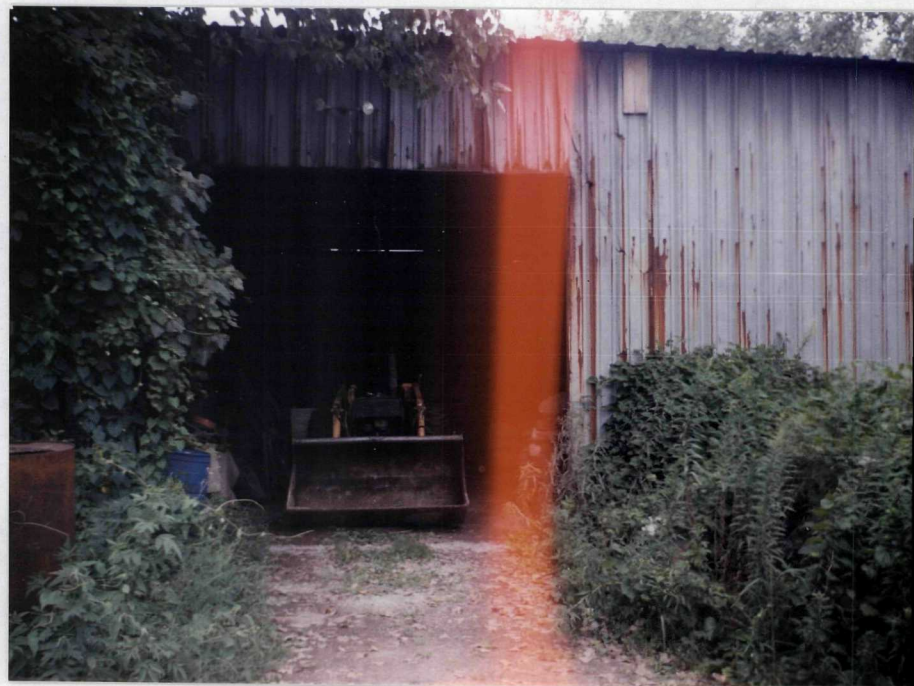
**Description:** Residential well and pump.
